DEPARTMENT OF TRANSPORTATION

Contract #: 04-0120F4Cty: SF/ALA Rte: 80 PM: 13.2/13.9File #: 69.28**WELDING INSPECTION REPORT****Resident Engineer:** Pursell, Gary**Address:** 333 Burma Road**City:** Oakland, CA 94607**Report No:** WIR-013173**Date Inspected:** 16-Apr-2010**Project Name:** SAS Superstructure**OSM Arrival Time:** 700**Prime Contractor:** American Bridge/Fluor Enterprises, a JV**OSM Departure Time:** 1900**Contractor:** Zhenhua Port Machinery Company, Ltd (ZPMC), Changxing Island **Location:** Shanghai, China**CWI Name:** Li Yang**CWI Present:** Yes No**Inspected CWI report:** Yes No N/A**Rod Oven in Use:** Yes No N/A**Electrode to specification:** Yes No N/A**Weld Procedures Followed:** Yes No N/A**Qualified Welders:** Yes No N/A**Verified Joint Fit-up:** Yes No N/A**Approved Drawings:** Yes No N/A**Approved WPS:** Yes No N/A**Delayed / Cancelled:** Yes No N/A**Bridge No:** 34-0006**Component:** OBG**Summary of Items Observed:**

WELDING INSPECTION REPORT

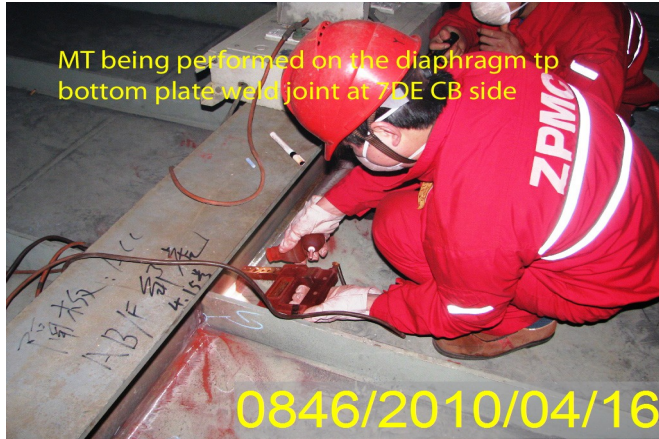
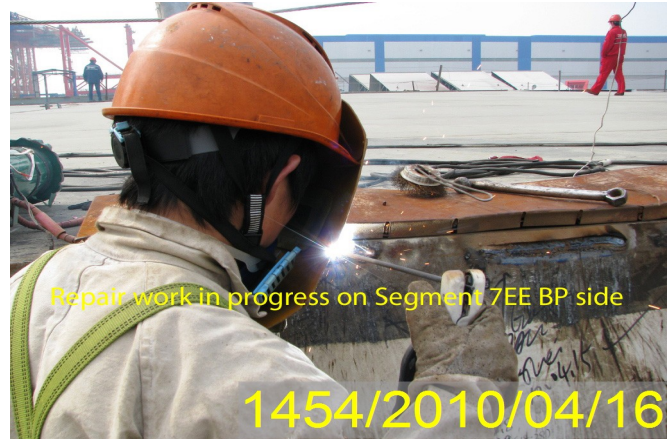
1. Ut reject excavation in progress at the deck plate to edge plate weld joint located at the bike path side of segment. Y locations are as followed: 11780mm (2 transverse cracks), 11330~11360mm, 10820mm, 7870~8260mm, 7460~7610mm, 684mm (2 transverse cracks).
